2023 Annual SHOT Report – Supplementary information

Chapter 10: Incorrect Blood Component Transfused (IBCT)

Additional analysis not included in the main 2023 Annual SHOT Report.

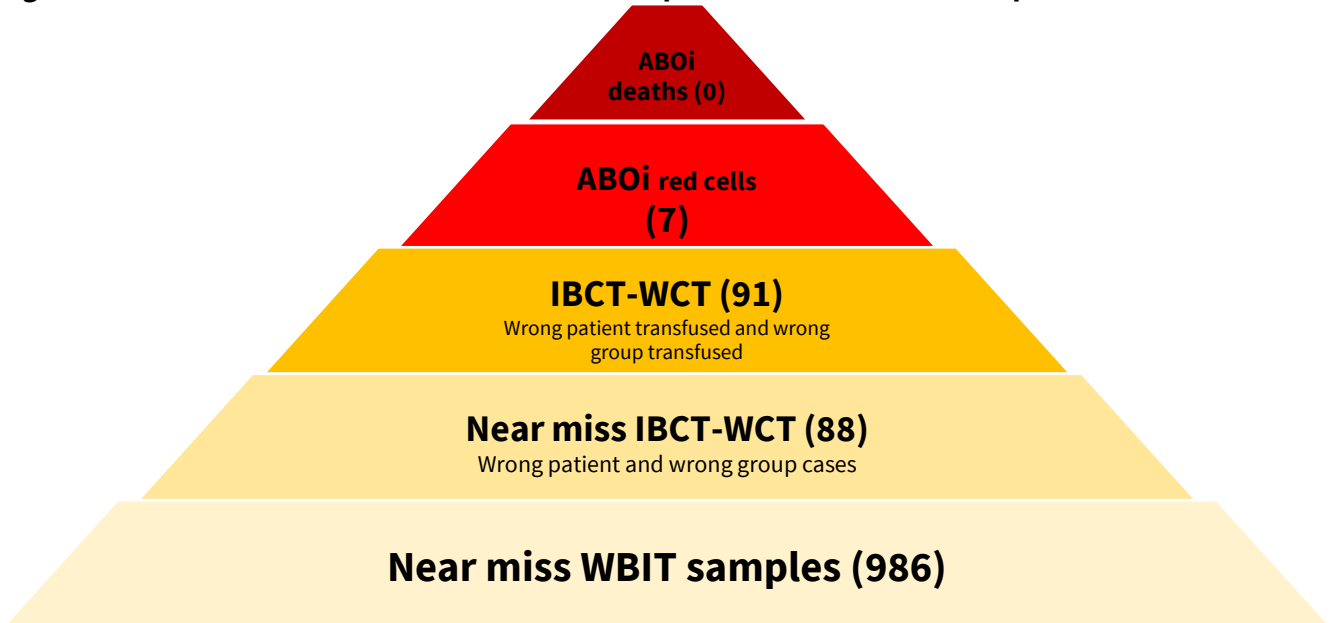
Fig 10.9: ABOi transfusions and events that had the potential to lead to ABOi reported in 2023

Figure 10.9 shows a summary of potential outcomes resulting from errors in the transfusion pathway.
