8 Incorrect Blood Component Transfused (IBCT) (clinical and laboratory errors)

The category of incorrect blood component transfused is divided into instances where a wrong component is transfused (WCT) and those where the specific requirements are not met (SRNM).

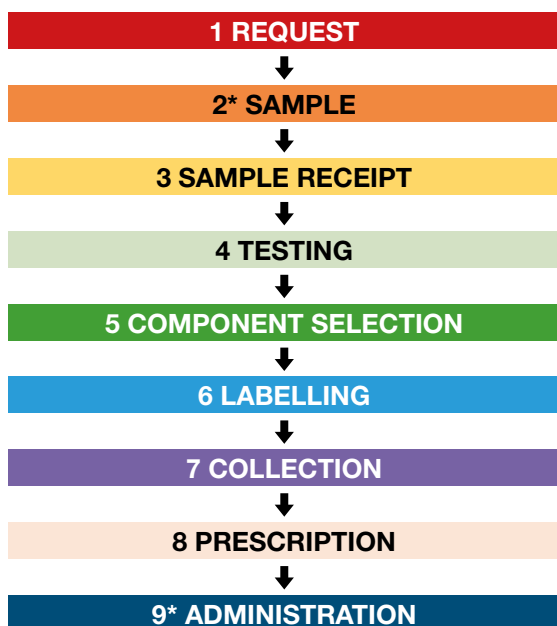
Figure 8.1:
Steps in the
transfusion process

Transfusion is a multidisciplinary activity with both the clinical and laboratory staff working in partnership as one integrated team. Each case that led to an incorrect blood component being transfused has been reviewed to find the steps where the error(s) could have been identified, Figure 8.1. These essential steps are clearly defined [23, 24] and should be followed using a checklist as previously recommended [21]. Each participant in the transfusion process is responsible for carrying out his/her own roles and ensuring that necessary checks are not overlooked and/or that no procedures are omitted.

* Critical points where positive patient identification is essential

The definitions of the steps in the transfusion process can be found in the British Committee for Standards in Haematology (BCSH) Guideline on Administration of Blood Components [23]. A complete summary and classification of all laboratory incidents is found in Chapter 9 Summary of Events Originating in the Hospital Transfusion Laboratory.

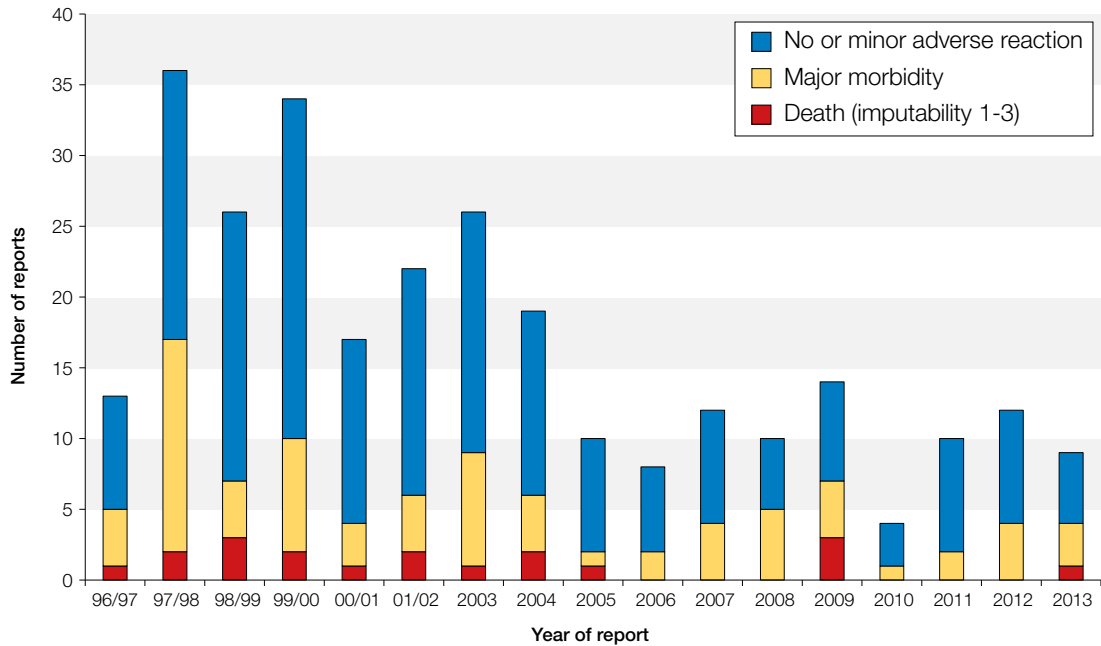
Figure 8.2:
Most ABO incompatible transfusions are not associated with serious outcomes

ABO incompatible red cell transfusions are one of the most feared outcomes of errors in the transfusion process. Review of cumulative data from SHOT reports shows a reduction after 2004 but a relatively constant number since then (Figure 8.2). There were a total of 14 deaths in the years before 2005, but 5 in the following 9 years.

Note: from 1998/99 to 2003 the SHOT reports do not specify whether the deaths and major morbidities were caused by red cells or other component types

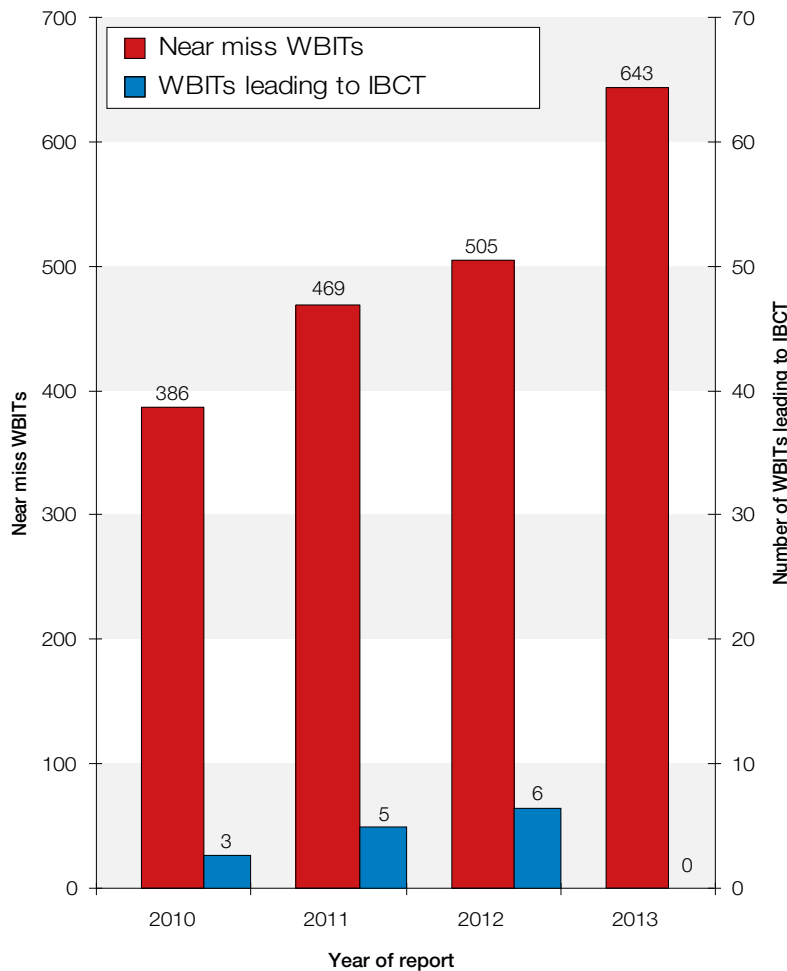
Figure 8.3:
Cumulative comparison of near miss WBIT and those leading to IBCT

In 2013 there were no proven cases of WBIT (one possible, see RhD mismatch above) that actually resulted in an incorrect blood component being transfused, which is a change from previous years. Reports to SHOT between 2010 and 2012 indicated approximately one incorrect blood component transfused due to a WBIT error for every 100 near miss incidents. However, in 2013 there were 643 reported WBIT near misses, but no confirmed transfusions of an incorrect blood component (Figure 8.3). The 2012 BCSH pre-transfusion compatibility guidelines [19] recommend that a group check sample should be requested for confirmation of the ABO group of a first time patient, but a single year's data

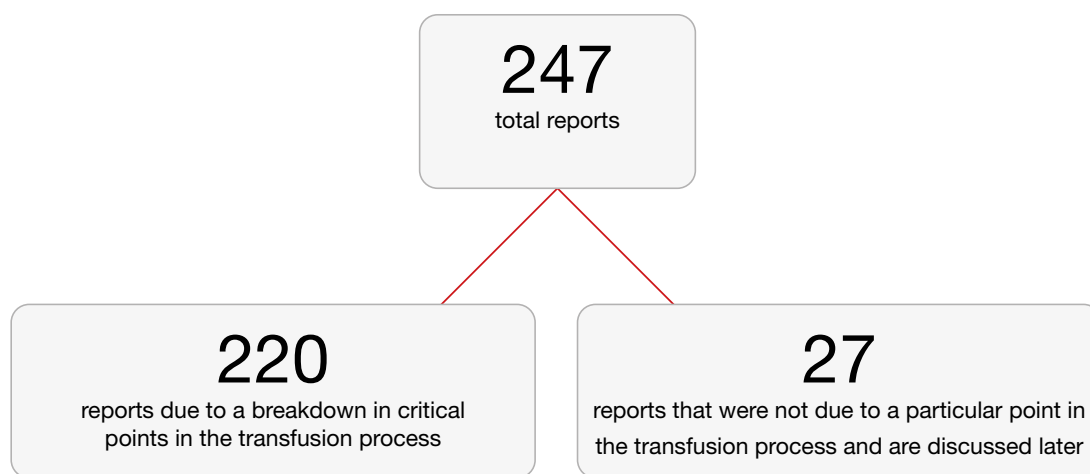
Figure 8.4:
Number of reports due to failure of correct steps in the transfusion process

A review of errors resulting in incorrect blood components transfused and missed opportunities for detection n=547 (220 reports)

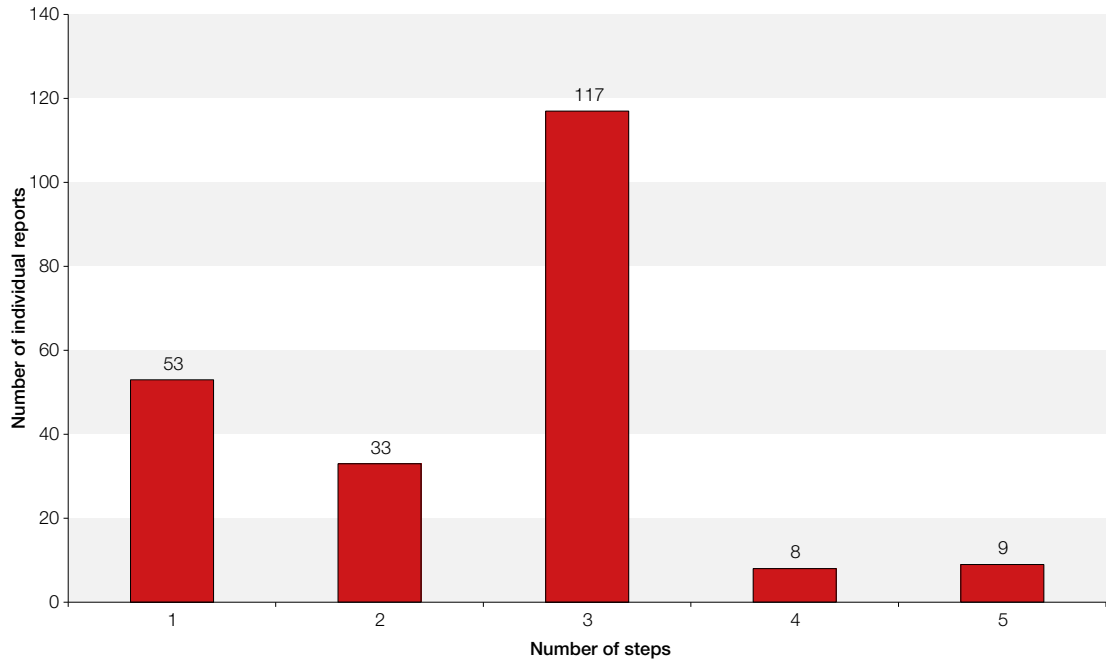
Figure 8.5:
 Number of steps
 where there was
 a critical point
 breakdown in the
 transfusion process
 n=220 reports

Figure 8.5 illustrates the number of cases that were analysed and the number of missed opportunities to detect an error (e.g. if a case has 3 missed opportunities, this means that there were 2 subsequent opportunities for the initial error to be detected).

Multiple errors in the transfusion process are common (the median number is 3 – Figure 8.5). How and where can they be detected?

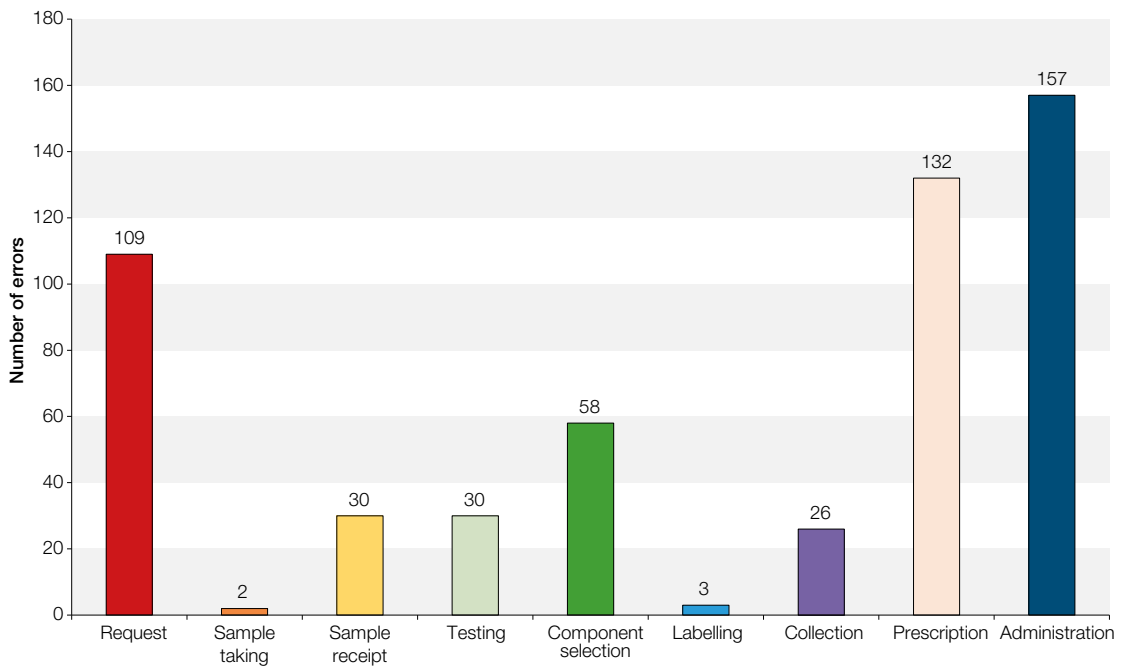
Figure 8.6:
 Steps in the
 process where an
 error was made or
 an opportunity was
 missed to detect
 the primary error
 n=547

The steps where errors are most likely to occur are shown in Table 8.8, but the opportunity to detect these is maximal at the time of checking against the prescription and before administration (Figure 8.6).

SHOT has noted in the past that many incident reports are compounded by more than one error. In some cases, 31/220 (14.1%), errors could have been detected in both laboratory and clinical areas. Many primary errors, 155/220 (70.5%), could have been detected at the final pre-administration checks at the bedside. It is crucial that this step is done properly.

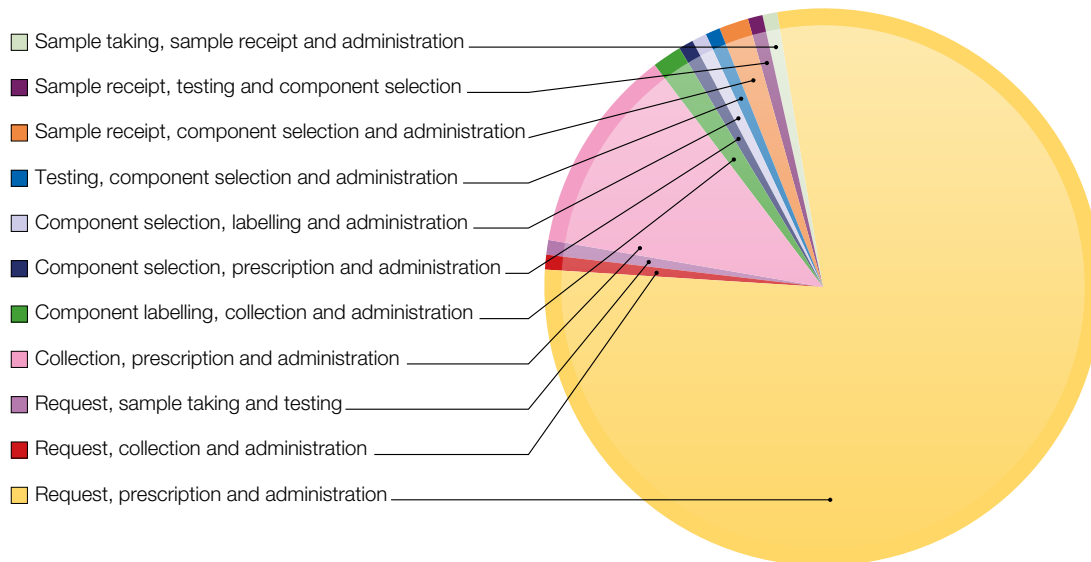
Figure 8.7:
Combinations of
primary error and
opportunities for
detection – 3 steps
n=117

This was the largest group, 53.2% (117/220). Most result from errors in requesting which were not then detected at prescription or administration. Most of these resulted in specific requirements not being met.

The slices show the different combinations of opportunities to find the errors and demonstrate that 'request, prescription and administration' is the most common combination of 3 steps (primary error and 2 missed opportunities to detect the primary error) n=92/117 (78.6%).

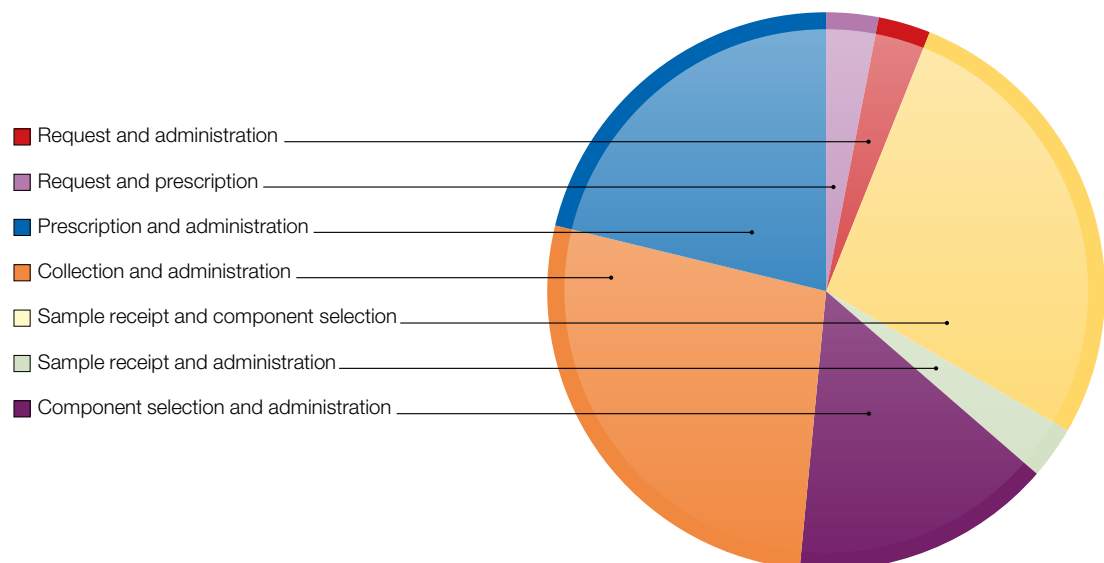
Figure 8.8:
Combinations of primary error and opportunities for detection, 2 steps n=33

There were 33 cases where the primary error could have been detected at a second point in the process.

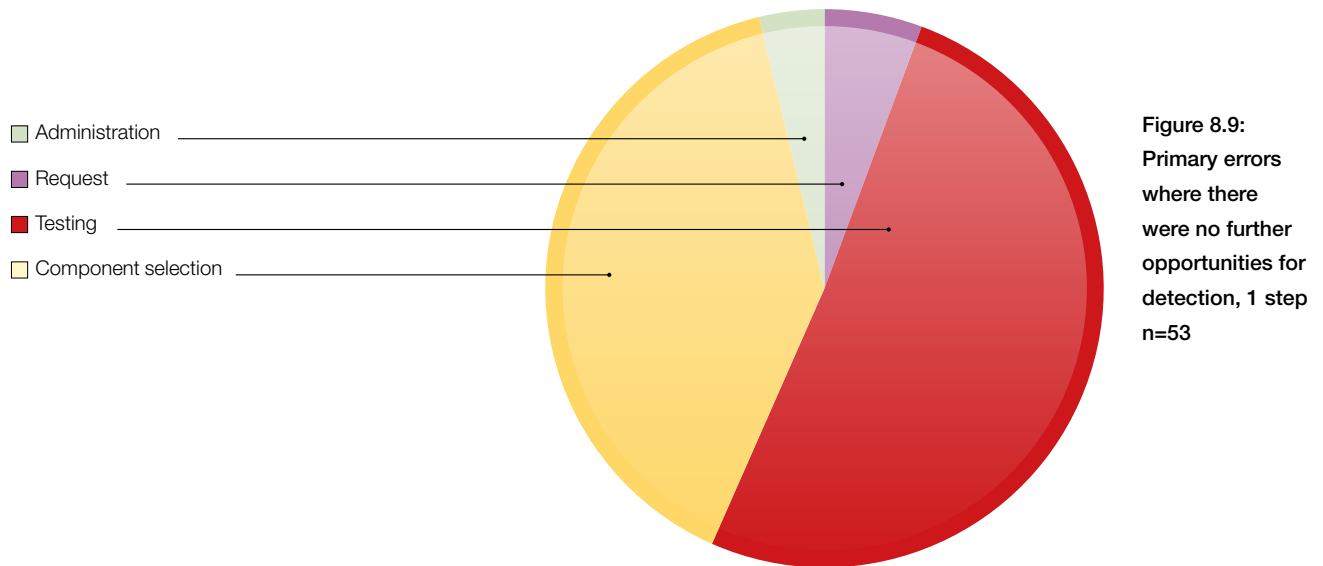
Figure 8.9: Primary errors where there were no further opportunities for detection, 1 step n=53

Single opportunity to prevent a wrong transfusion n=53

In 53/220 (24.1%) reports, a single error was made. These occurred at several different stages in the process: the request, testing, component selection, and administration. However, laboratory errors were responsible for 48/53 (90.6%) of these cases. All laboratory errors are discussed in more detail in Chapter 9 Summary of Events Originating in the Hospital Transfusion Laboratory.
